## **GEOPHYSICAL INVESTIGATION INTO THE REMOTE CAUSES OF ROAD FAILURE ALONG FARIN GADA- ZABOLO ROAD, JOS, NORTH CENTRAL NIGERIA**

### **ABSTRACT**

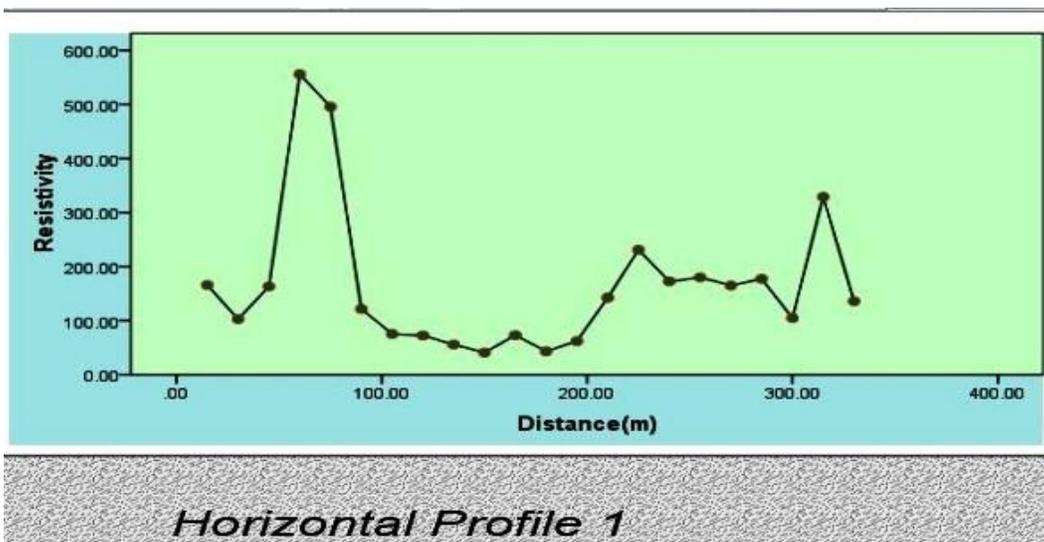
**Table 3a:** Summary of the Geoelectric parameters for horizontal profile 1

HP	Area	Resistance(ohm)	Resistivity(ohm-m)	Remark
1	15	1.76	165.94	Slightly Competent
2	15	1.09	102.73	Slightly Competent
3	15	1.73	163.04	Slightly Competent
4	15	5.90	556.06	Competent
5	15	5.26	495.74	Competent
6	15	1.29	121.57	Slightly Competent
7	15	0.799	75.30	Incompetent
8	15	0.769	72.47	Incompetent
9	15	0.591	55.70	Incompetent
10	15	0.433	40.80	Incompetent
11	15	0.775	73.04	Incompetent
12	15	0.457	43.07	Incompetent
13	15	0.659	62.10	Incompetent
14	15	1.51	142.31	Slightly Competent
15	15	2.45	230.90	Slightly Competent
16	15	1.83	172.47	Slightly Competent
17	15	1.91	180.01	Slightly Competent
18	15	1.75	164.93	Slightly Competent
19	15	1.88	177.18	Slightly Competent
20	15	1.11	104.61	Slightly Competent
21	15	3.49	328.92	Slightly Competent
22	15	1.44	135.71	Slightly Competent

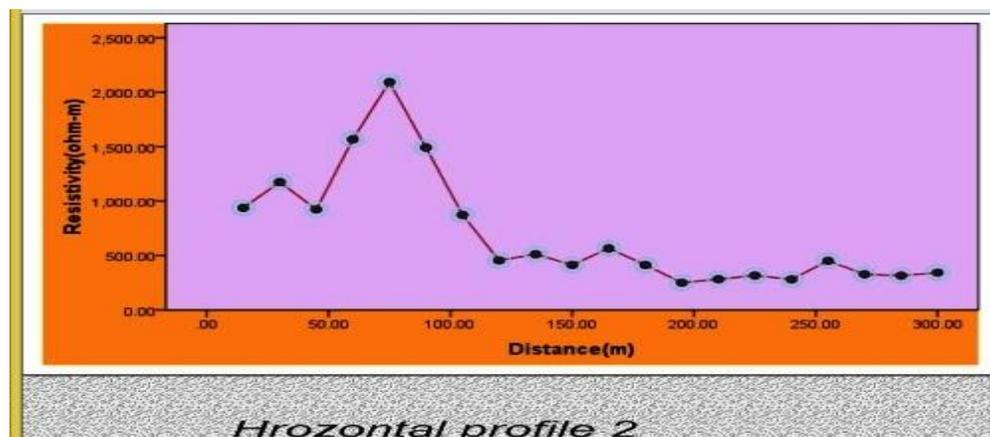
**Table 3b:** Summary of the Geoelectric parameters for horizontal profile 2

HP	Area	Resistance(ohm)	Resistivity (ohm-m)	Remark
1	15	9.95	937.76	Highly Competent
2	15	12.46	1174.32	Highly Competent
3	15	9.80	923.62	Highly Competent
4	15	16.63	1567.34	Highly Competent
5	15	22.20	2092.30	Highly Competent
6	15	15.83	1491.94	Highly Competent
7	15	9.72	873.67	Highly Competent
8	15	4.83	455.20	Competent
9	15	5.43	511.76	Competent
10	15	4.39	413.74	Competent
11	15	6.00	565.48	Competent
12	15	4.54	413.74	Competent
13	15	2.65	249.74	Slightly Competent
14	15	3.00	282.74	Slightly Competent
15	15	3.36	316.67	Slightly Competent
16	15	2.98	280.85	Slightly Competent
17	15	4.79	451.44	Competent
18	15	3.47	327.03	Slightly Competent
19	15	3.35	315.73	Slightly Competent
20	15	3.64	343.06	Slightly Competent
21	15	1.44	135.71	Slightly Competent
22	15	1.44	135.71	Slightly Competent

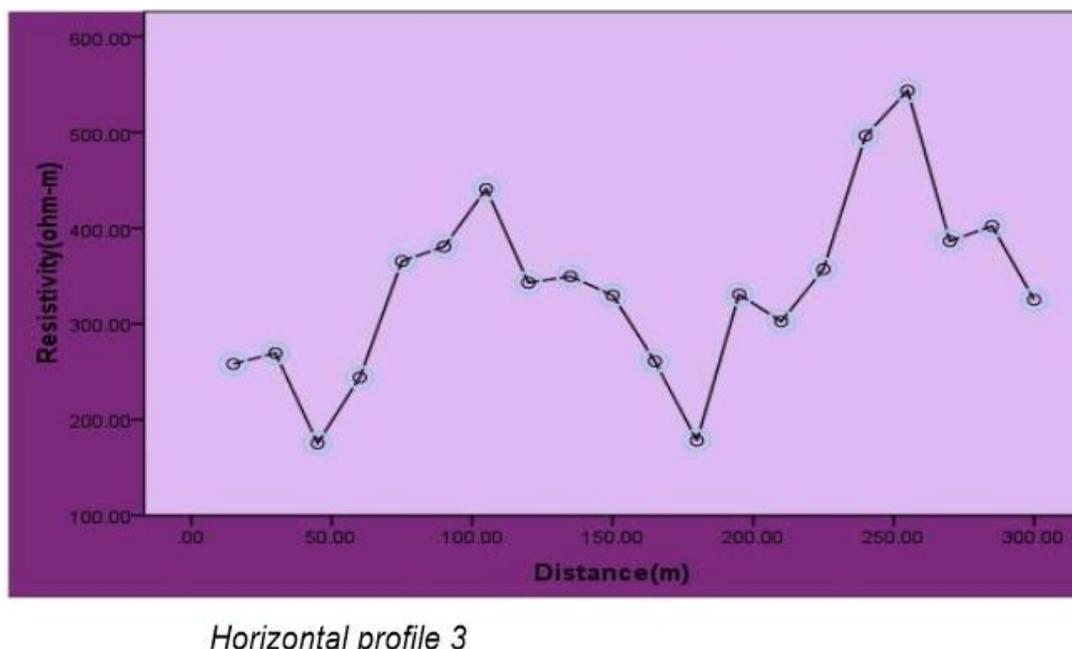
**Table 3c:** Summary of the Geoelectric parameters for horizontal profile 3

HEP	Area	Resistance(ohm)	Resistivity(ohm-m)	Remark
1	15	2.74	258.23	Slightly Competent
2	15	2.86	269.54	Slightly Competent
3	15	1.86	175.30	Slightly Competent
4	15	2.59	244.10	Slightly Competent
5	15	3.88	365.68	Competent
6	15	4.04	380.76	Competent
7	15	4.68	441.07	Competent
8	15	3.64	343.06	Slightly Competent
9	15	3.71	349.65	Slightly Competent
10	15	3.50	329.86	Slightly Competent
11	15	2.77	261.06	Slightly Competent
12	15	1.89	178.12	Slightly Competent
13	15	3.51	330.80	Slightly Competent
14	15	3.21	302.53	Slightly Competent
15	15	3.79	357.19	Competent
16	15	5.27	496.68	Competent
17	15	5.77	543.80	Competent
18	15	4.10	386.41	Competent
19	15	4.27	402.43	Competent
20	15	3.45	325.15	Slightly Competent

In other to interpret the result of the tests carried out above, a chart showing the rating of the subsoil competence using resistivity values was put forward by Boyawa and Olayiwola, (2015)(Table. 1). The chart was used for the competence rating of the soils in all the profiles. From the results obtained from the interpretation of the Werner array, only the soils around horizontal electrical profile, HEP2, were competent because of their high resistivity values that ranged from 343.06  $\Omega\text{m}$  to 2092.30 $\Omega\text{m}$  and were gotten from the undamaged sections of the road which was mainly made up of sand particles. At HEP1 and HEP3, soils around these profiles are incompetent because of their low resistivity values that ranged from 40.80 $\Omega\text{m}$  to 197.4 $\Omega\text{m}$  and were gotten from the damaged sections of the road and were mainly made up of clay (kaolin). At HEP2, VES 9,11,13,14 and 15 were taken at the undamaged sections of the road while at HEP1 and HEP3, VES 1,2,3,4,5,6,7,8,10,12,16,17,18,19,20,21,22,23,24 and 25 were taken from the damaged sections of the road which equally conforms with the result gotten from the schlumberger array investigation.
